ISSUE 29 - APR-MAY-JUN 90

SECTION 3 - AMIGA

-
- 29/3-0.0 INDEX - AMIGA SECTION TECHTOPICS ISSUE 29.
 - 29/3-1.1 A2091 MEMORY AUTO-CONFIGURATION LIMITATIONS.
 - 29/3-2.1 A2091 IC MEMORY 262,144 ADDRESS X 4 BIT DRAM.

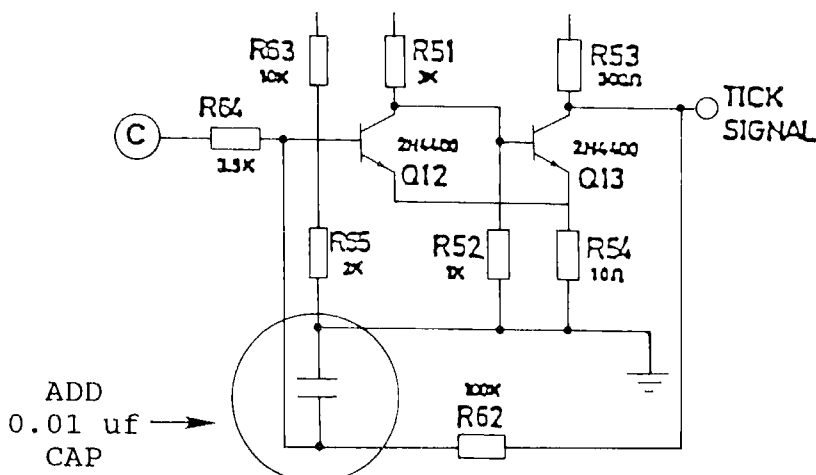
A2000 SYSTEM CLOCK FIX DIAGRAM

A WARRANTY LABOR RATE OF \$20.00 WILL BE CREDITED FOR THE FOLLOWING FIX ON THE ELTEK TYPE POWER SUPPLY TO CORRECT NOISE ON TICK SIGNAL. NOTE, A WHITE '00' STICKER IS ON POWER SUPPLIES WHICH HAVE THE MODIFICATION INSTALLED.

REFER TO ATTACHEMENT, ELTEK POWER SUPPLY SCHEMATIC. CHECK PIN 14 (TICK SIGNAL) OF CN400 WITH SCOPE FOR NOISE. ADD, ON POWER SUPPLY, 0.01 UF CAPACITOR BETWEEN R65 (GND SIDE), AND R62, AS INDICATED IN DETAIL DIAGRAM BELOW.
